# Case Study

Non profit structural monitoring in Beirut

A project of Amann Engineering

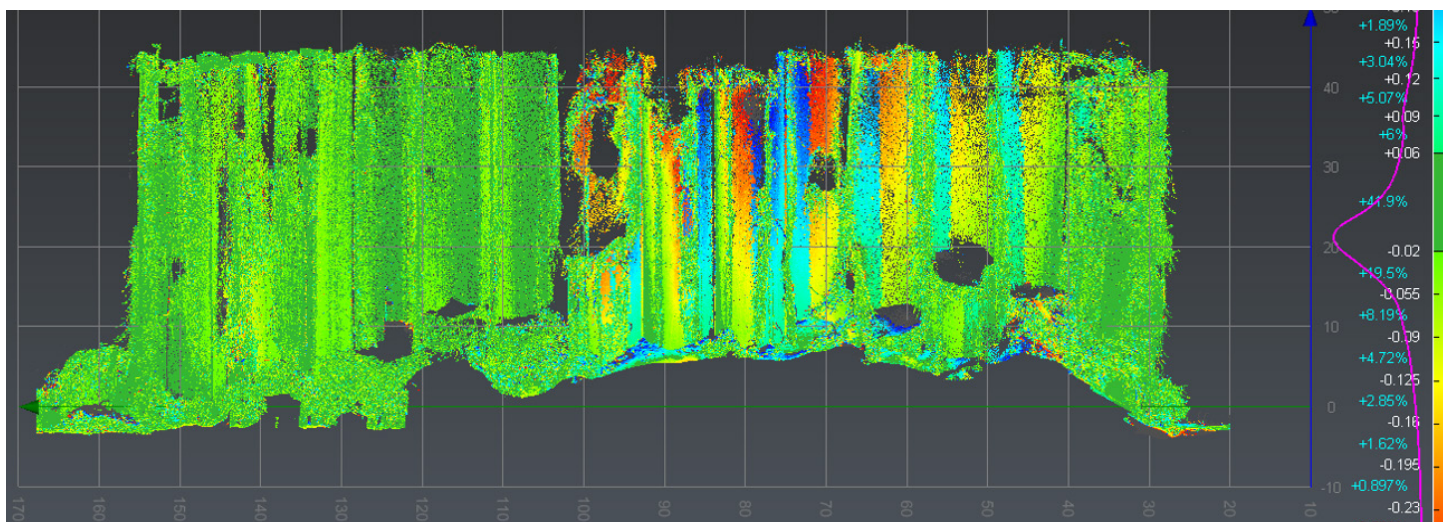
*Illustration of the 3D deviation analysis of the scan data over several months*

Starting in September 2020 the main focus during the three project phases was on monitoring and assessing the damage and deformation of the silos. The scan project was continued in November 2020 as well as late March and mid-April 2021. From phase 2 on, Emmanuel Durand and his team were equipped and supported with a Z+F IMAGER® 5010X to capture the data and to obtain 3D measurements with high precision and fine details. These 3D scans detect the silos' deformations that can not be captured by the naked eye and therefore need detailed scan recording.

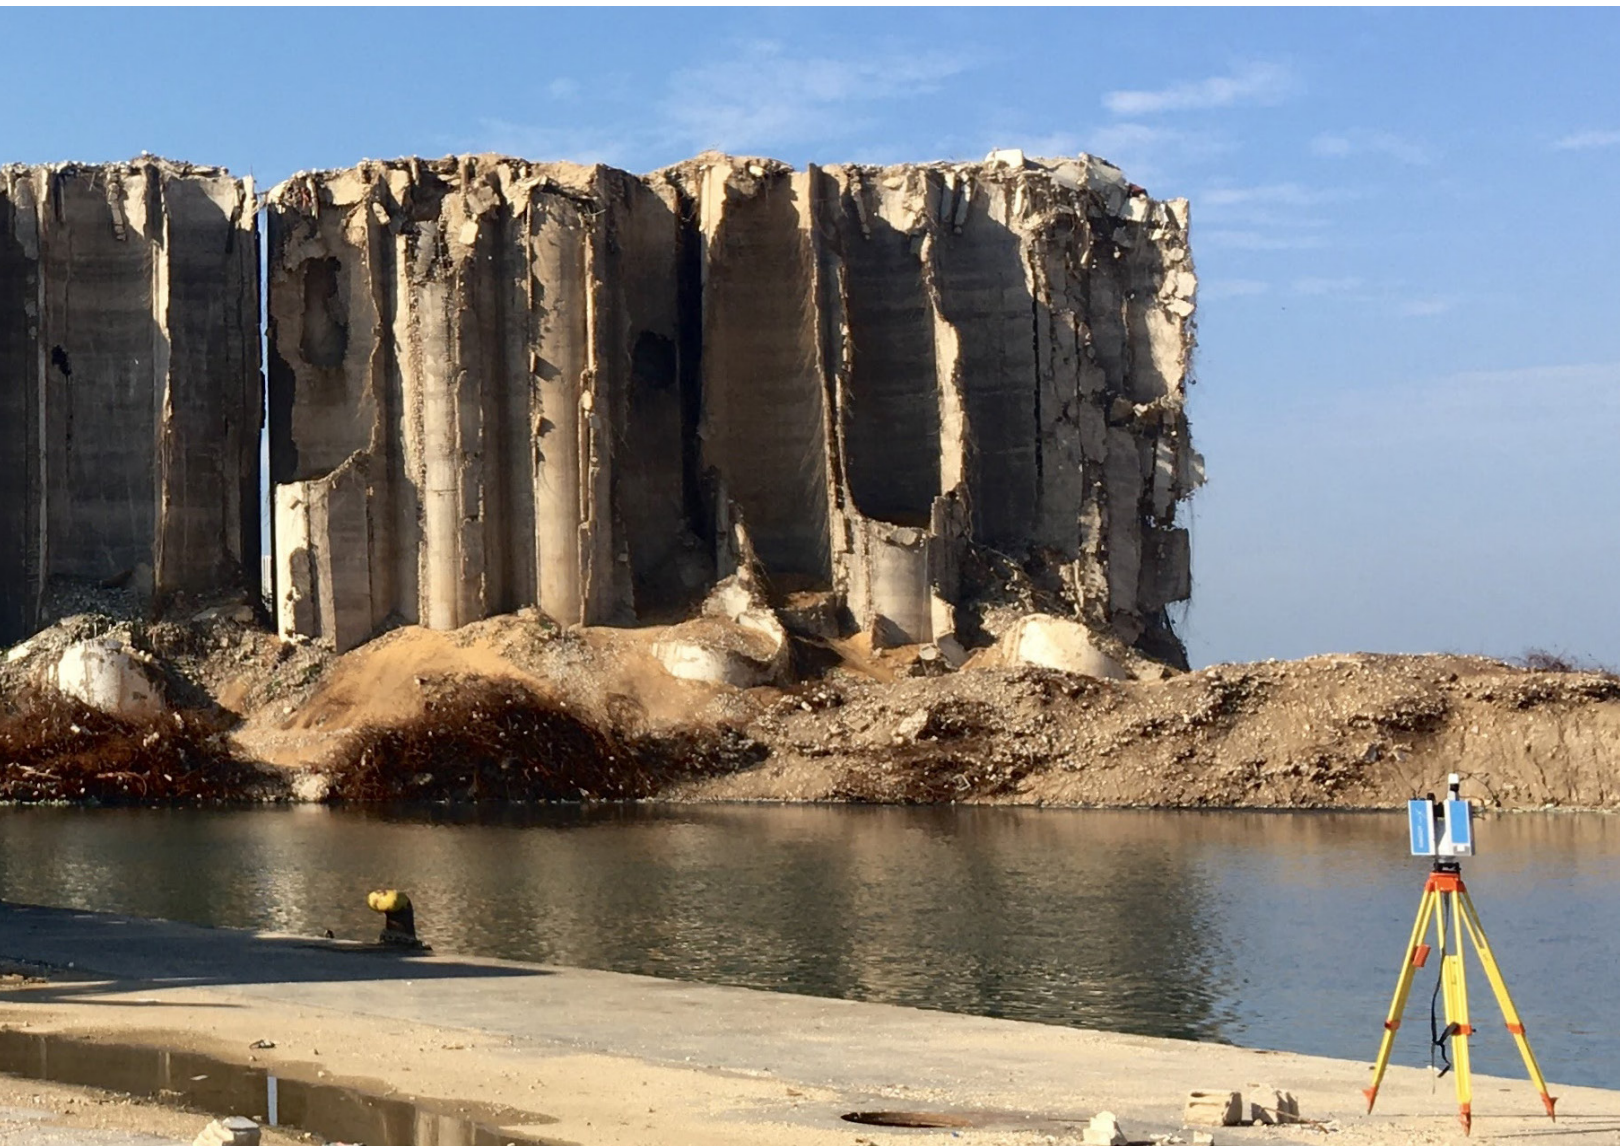
*Z+F Imager® 5010X in front of Beirut port silos*
